## Pine Straw Build-Up on Prepainted Metal Roofing

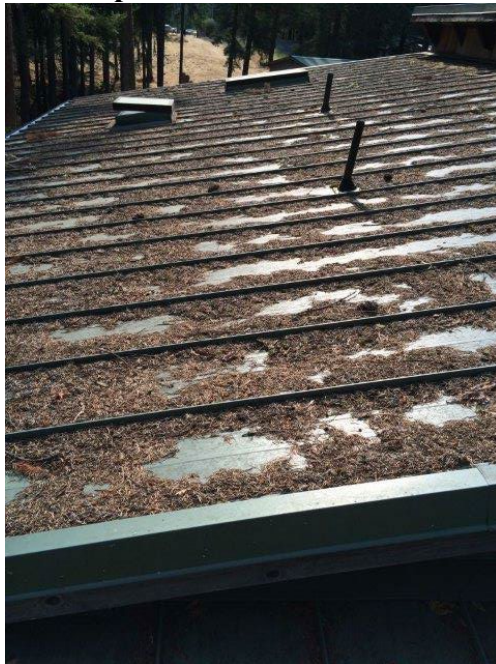
An issue, while not limited to the US Pacific Northwest, but certainly prevalent there, is the accumulation of pine needles (also called “pine straw”) on prepainted metal roofing. Although metal roofing is better than asphalt shingles when it comes to shedding leaves, twigs, pine straw, etc., there will be occasions when build-up may occur. See an example below.

### Build-Up of Pine Straw

Prepainted metal will provide decades of performance, but it is important to avoid pooling water and build-up of water-laden debris, especially pine needles. It is, however, beyond the scope of this document to specify how this is to be done. Reputable suppliers of prepainted metal can provide specific maintenance and cleaning guidelines.

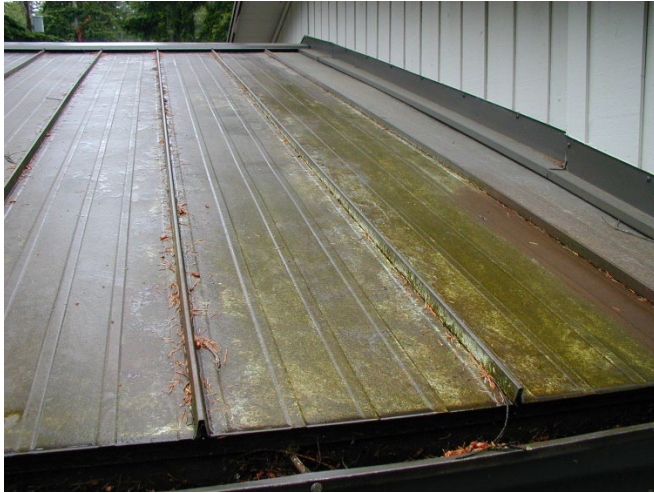
In many cases, this build-up may be harmless, but some failures of the prepainted metal have been noticed where build-up—especially of pine needles—has occurred, as shown here:

### Panel condition after removal of an accumulation of pine needles

There are two primary failure pathways that may explain such failures:

1. Water saturating the pine straw debris on the roof. Long-term exposure of a paint system to moisture may present a problem under some conditions. Although prepainted metal is very resistant to moisture ingress, all coatings and sealants have some degree of permeability, so it is always advisable to avoid any condition where moisture is trapped against a prepaint metal surface.

2. All biologic materials are very complex mixtures of a great many of organic compounds. Oak leaves contain tannins, which are mildly acidic. Pine needles are particularly interesting. The various species of pine trees produce varying types—and varying amounts of—organic compounds. Perhaps the most common chemicals are:

- d. Eugenol: an oil also found in clove, nutmeg and cinnamon.
  - e. Limonene: This is the organic compound of greatest concern. Although it is chemically similar to the above compounds, it has one distinctly different property. Limonene has been formulated into a number of “green” paint strippers, and also can be used as a cleaning solvent for removing oils on machine parts. In addition to pine needles, limonene is found in the peels of citrus fruits.

These “green” strippers are not nearly as aggressive as past strippers that contained a number of aggressive and hazardous chemicals. It is easy to conceive of a situation, however, where a pile of pine needles, resting on a pre-painted metal roof for months or years, would release enough limonene to attack the painted surface and perhaps even the metallic-coated steel or aluminum substrate.

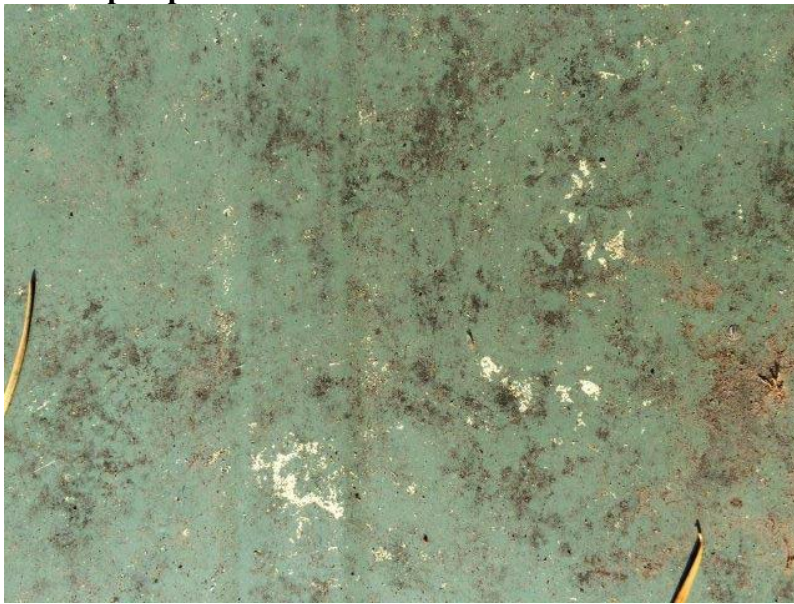
### Close-up of painted surface after removal of an accumulation of pine needles
