Pressure Mottling

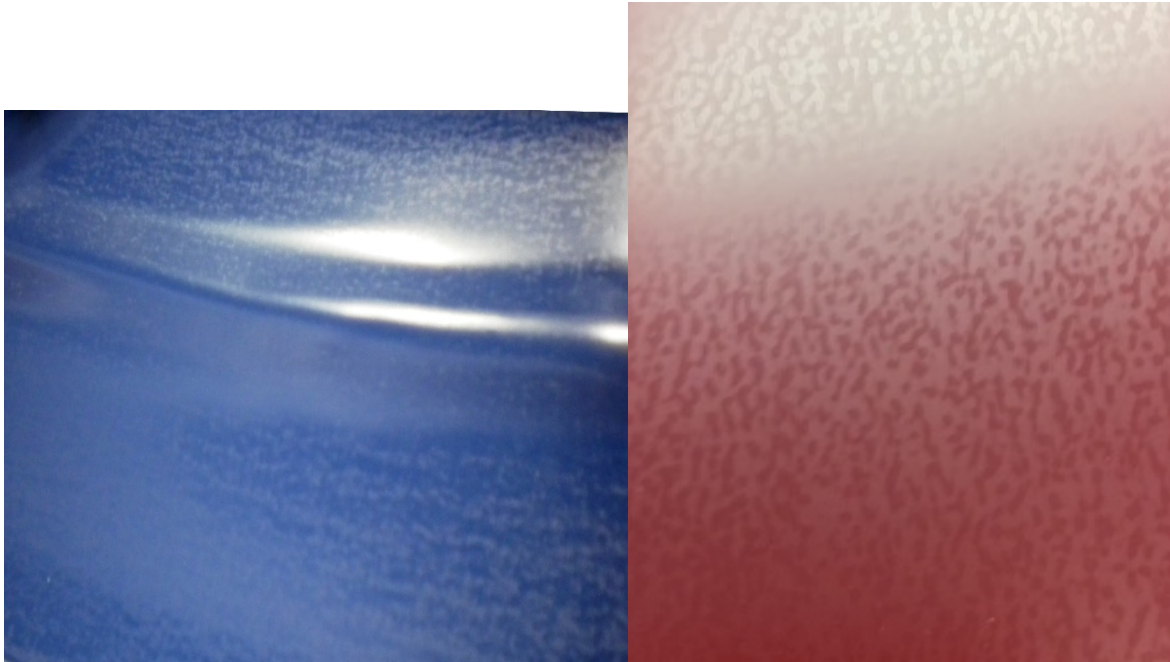
Pressure mottling, also known as pressure marking or imprinting, is an uneven or irregular gloss pattern on the face of a coil sheet. It is generally caused by disparity in the gloss between the top and bottom surfaces of a coil. These gloss differences are then transferred with time and pressure to either surface causing the irregular pattern. Figure 1 shows two examples of pressure mottling.

The distortion is typically temporary and will dissipate with time and exposure to heat or ambient conditions. In extreme cases where heat and pressure have created an excessive degree of marking/mottling, the distortion is permanent and will not dissipate under ambient conditions. In all cases, pressure mottling is an aesthetic issue and will not affect the long-term mechanical and durability performance of the coated metal system.

- Major gloss difference between the topcoat and the back coat
- Glass transition temperatures of the polymers used in the topcoat and the back coat
- Differences in cross-linking densities between the topcoat and the back coat.
- High rewind tension
- Temperature (i.e., the coil is wrapped too hot, wet, or subjected to conditions that allow condensation in the coil, etc.).

NOTE: Pressure mottling is often heavier in the center of the strip due to the crown in the substrate and tension being higher in this area.

To eliminate pressure mottling that already exists, the strip may be heated, which relieves the stresses with the mottled area and results in a smoothing effect. Typically the heat generated during the fabrication process or as the material is exposed to outdoor conditions is sufficient. In all but the most severe cases, the coating will "recover" (expand) within a few days after the "pressure" is removed.

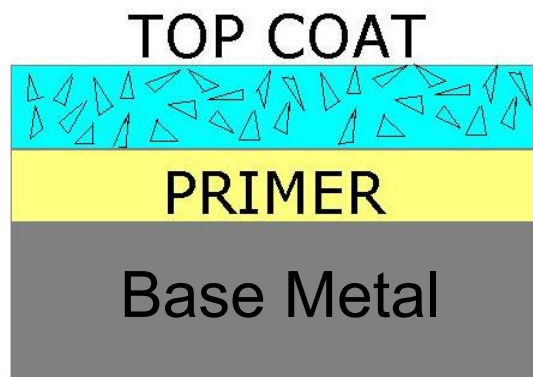
Figures 2 and 3 illustrate how pressure mottling occurs. The gloss components in Figure 2 are under normal suspension within the topcoat and the direction is random throughout. When pressure mottling takes place, the gloss components are suppressed or flattened within the topcoat as seen in Figure 3. Only the components closest to the surface are affected, and this results in the variance in gloss across the strip.

Sample crossview showing gloss components in normal suspension

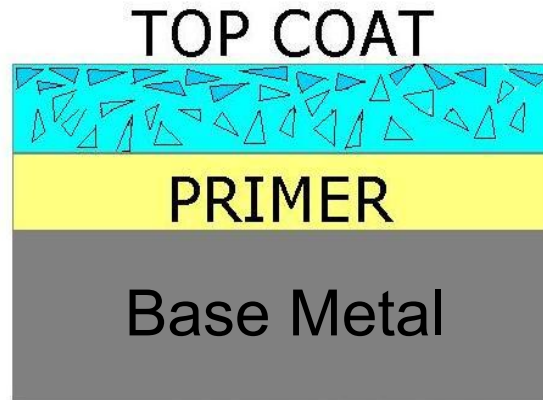
Figure 3

Sample crossview showing
"suppressed" gloss components
